CLIMATE BASELINE ASSESSMENT MUNICIPALITY OF SELENICË

BUILD GREEN GROUP & MUNICIPALITY OF SELENICE

JULY, 2025

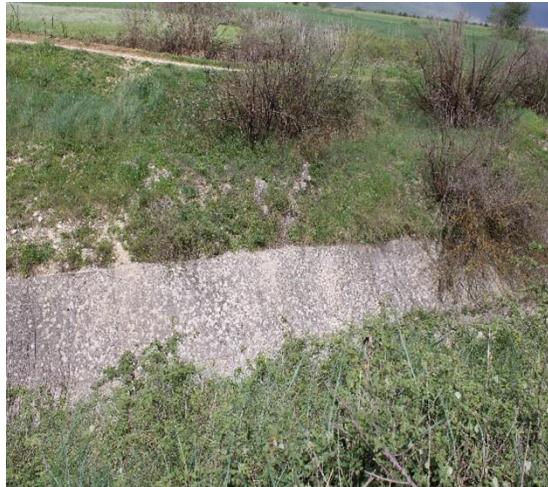
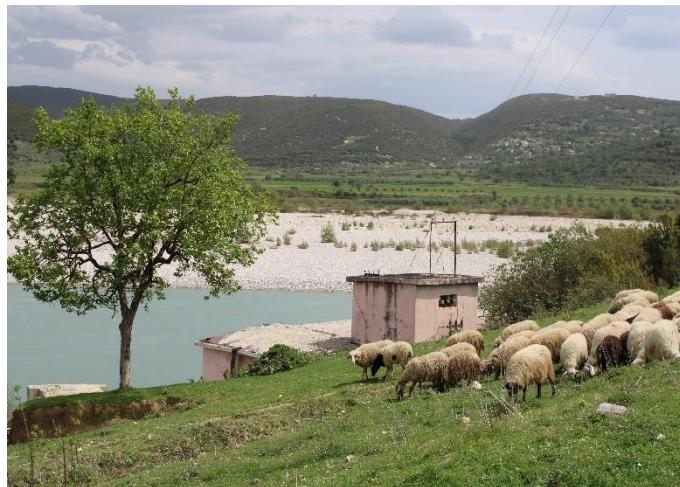
Water intake station on the Vjosa river, Shkozë, Sevaster and the main irrigation canal

- Non-functioning of one of the main irrigation canals that is supplied by mechanical lift;
- Need for rehabilitation of the existing system of primary, secondary and tertiary canals;.
- The pumping station requires replacement with more powerful pumps.

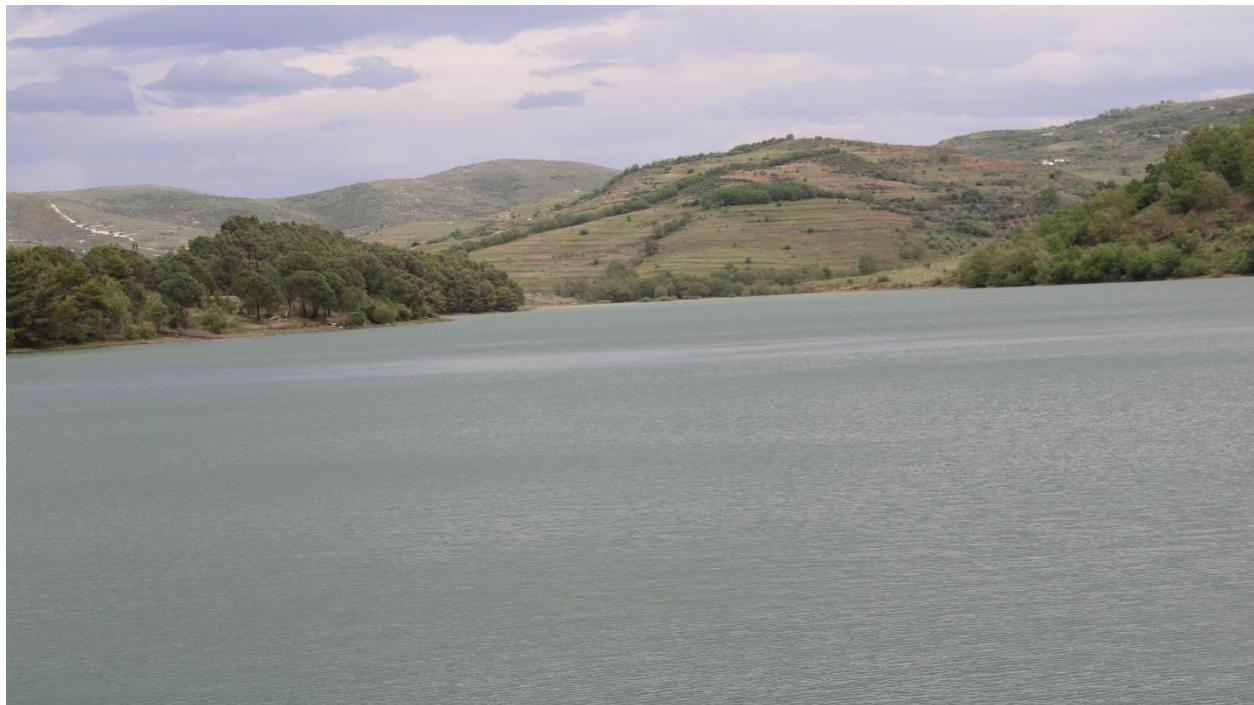
Figure XVIII. Picture from the Harvalë reservoir, Amonicë

In 2021, an intervention was carried out on the emergency spillway to prevent leaks. However, the valves are out of function (do not open and close), while the outlet and spillway have structural damages. The dam itself is in good condition, but the entire structure requires complete rehabilitation, both for irrigation purposes and to increase dam safety.

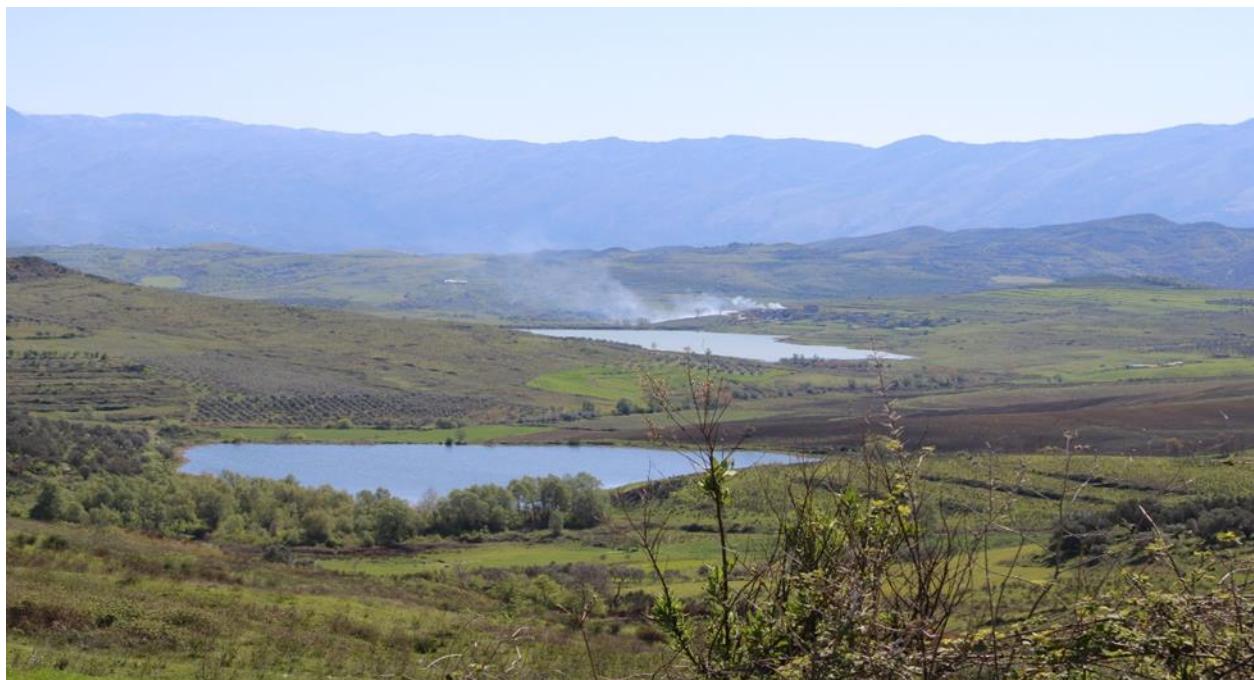
Figure XIX. Picture from Petë reservoir (Petë village)

This is a smaller reservoir, with an irrigation capacity of about 20 ha, but it has lost most of its volume due to sedimentation. Currently, it is out of function, as the sluice gate is blocked.

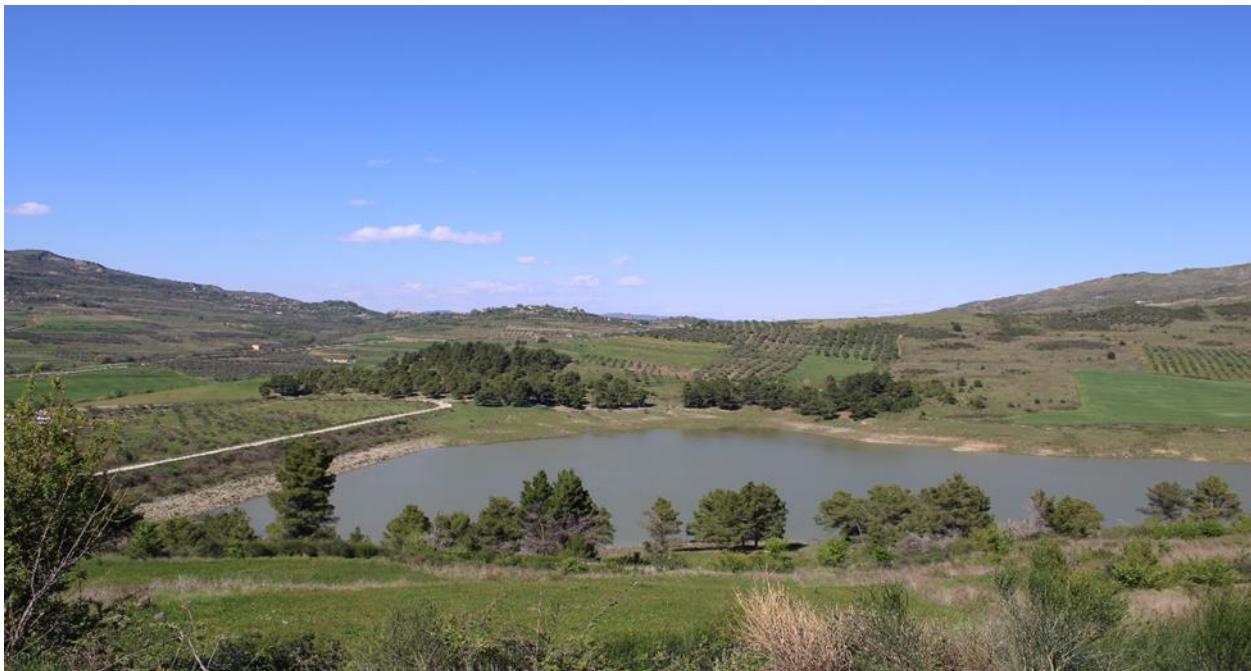
Figure XX. Vllahinë Reservoir, Vllahinë Administrative Unit

The reservoir has lost its irrigation function and is currently out of function due to problems with the dam and the malfunctioning of the spillway, which is damaged. The difficulties began at the time of the transfer of ownership to the administration of the municipality.

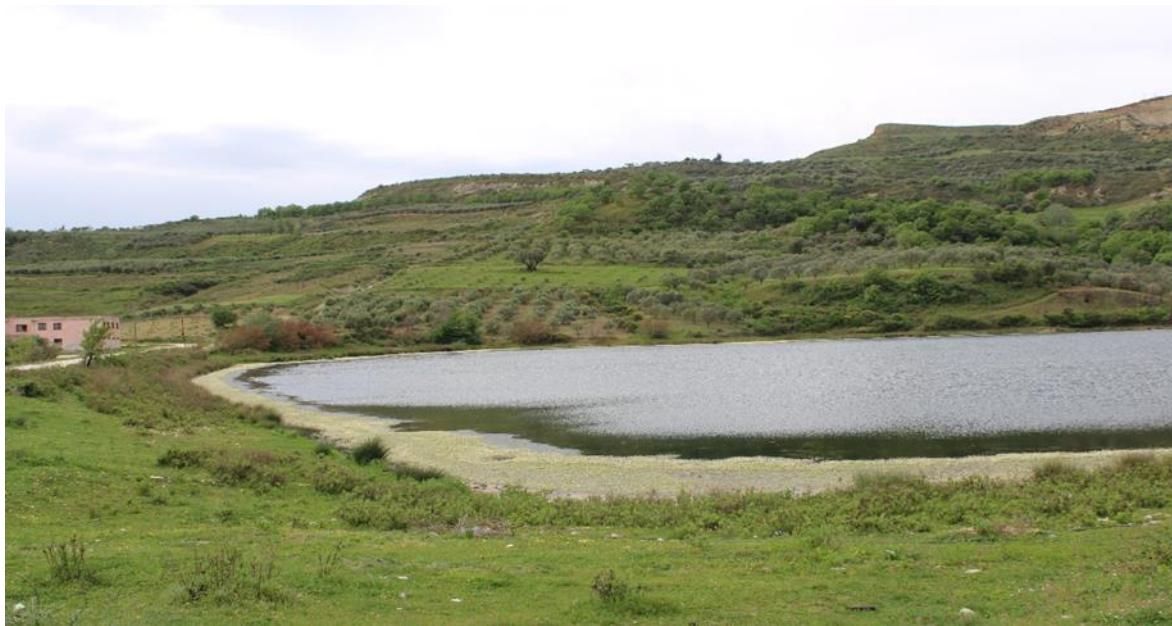
Figure XXI. Kocul Reservoir, Vllahinë Administrative Unit

Rehabilitation of the dam and spillway is required to restore the function of the reservoir and to avoid further risks to the area.

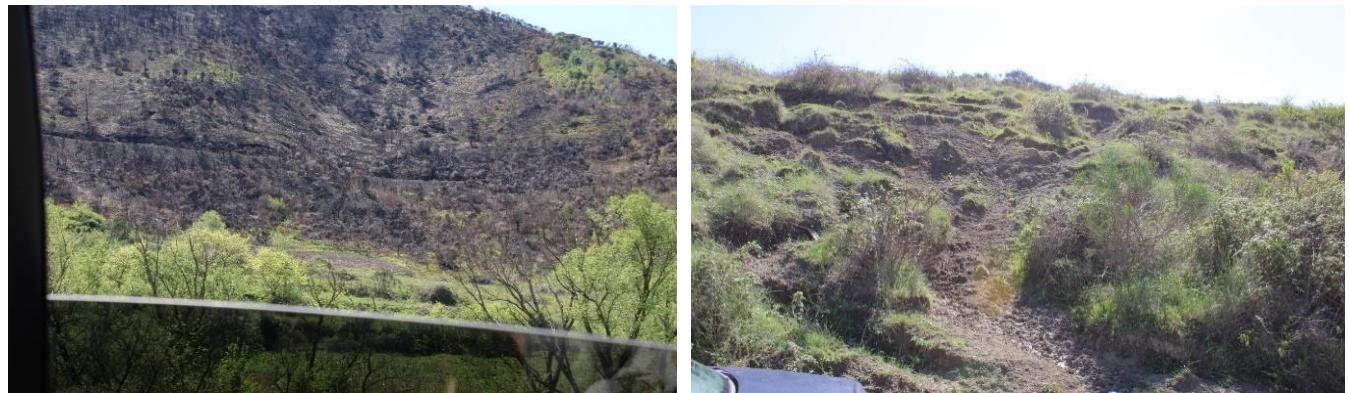
Figura XXIV. Pictures from forest and pasture fires in Vllahinë and land erosion in Gerdec

- Fires during high temperatures and **landslides**, especially in uncultivated or previously burned areas. In 2024, 290 ha of forests and 666 ha of pastures in the Municipality of Selenicë were affected by fires.

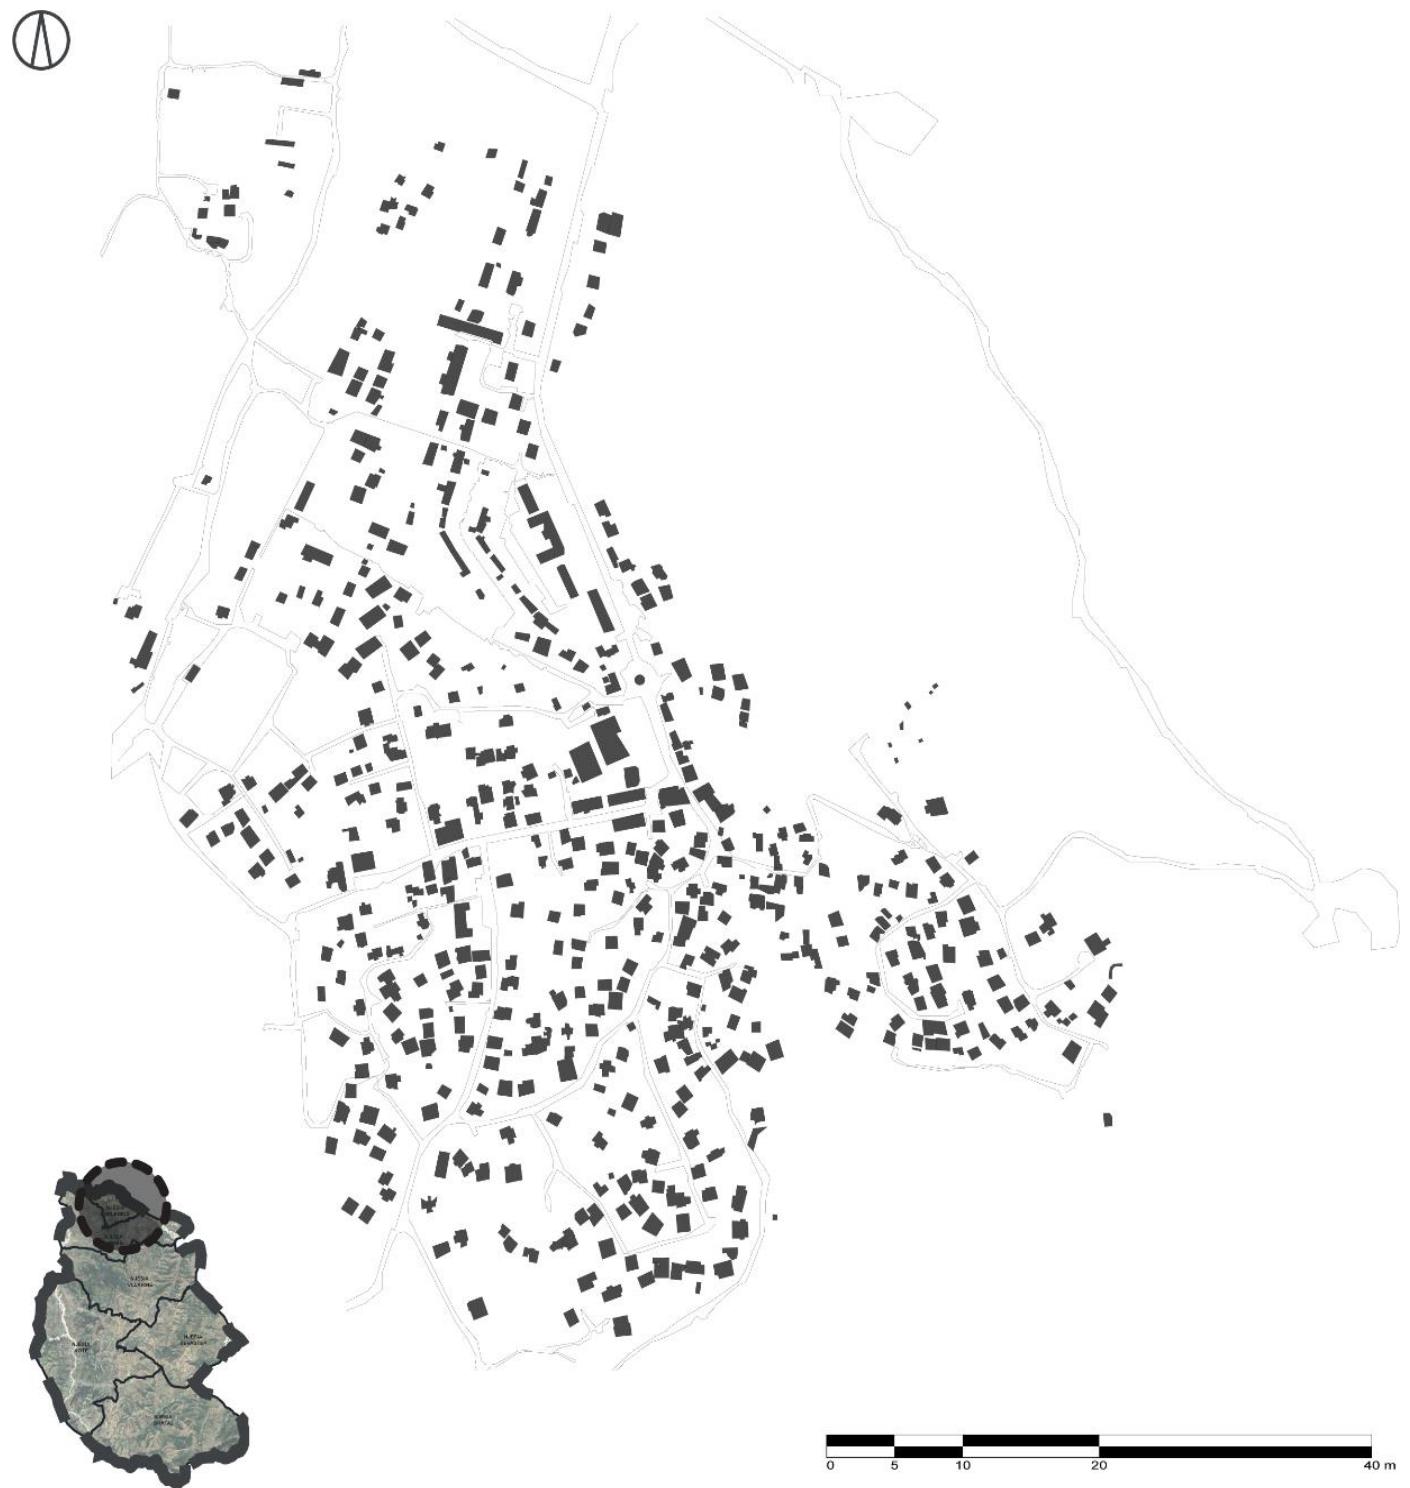
Figure XXIX. Digitalization of buildings in the city of Selenicë within a 600m radius in relation to the assessment of renewable energy potential

This typological and functional fragmentation negatively affects urban integration and creates the need for a differentiated intervention strategy that combines heritage preservation, structural improvement, and energy efficiency measures. In this context, the approach should be based on specific analyses for each building group, including gradual interventions starting with buildings in moderate condition that have high potential for rehabilitation. To ensure long-term sustainability and investment efficiency, it is essential that every measure is accompanied by an assessment of the potential for integrating renewable energy sources.
